FIELD TESTS OF THE CUCARACHA FORMATION, PANAMA CANAL, 1942-1946

C. K. Smith, R. J. Lutton

May 1974

Conducted by U. S. Army Engineer Waterways Experiment Station
Soils and Pavements Laboratory
Vicksburg, Mississippi

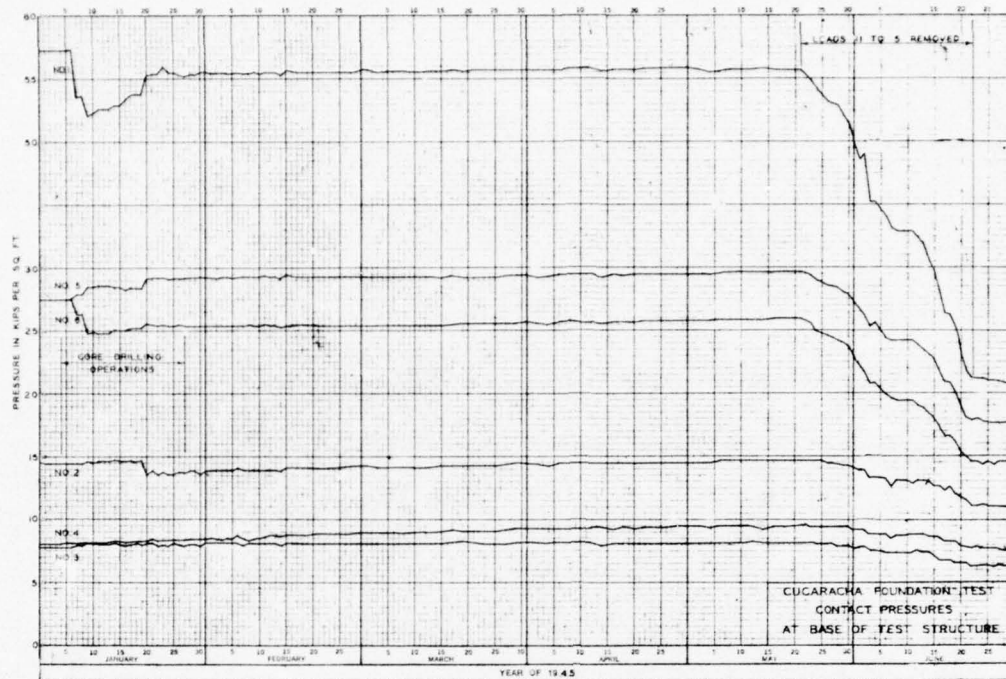
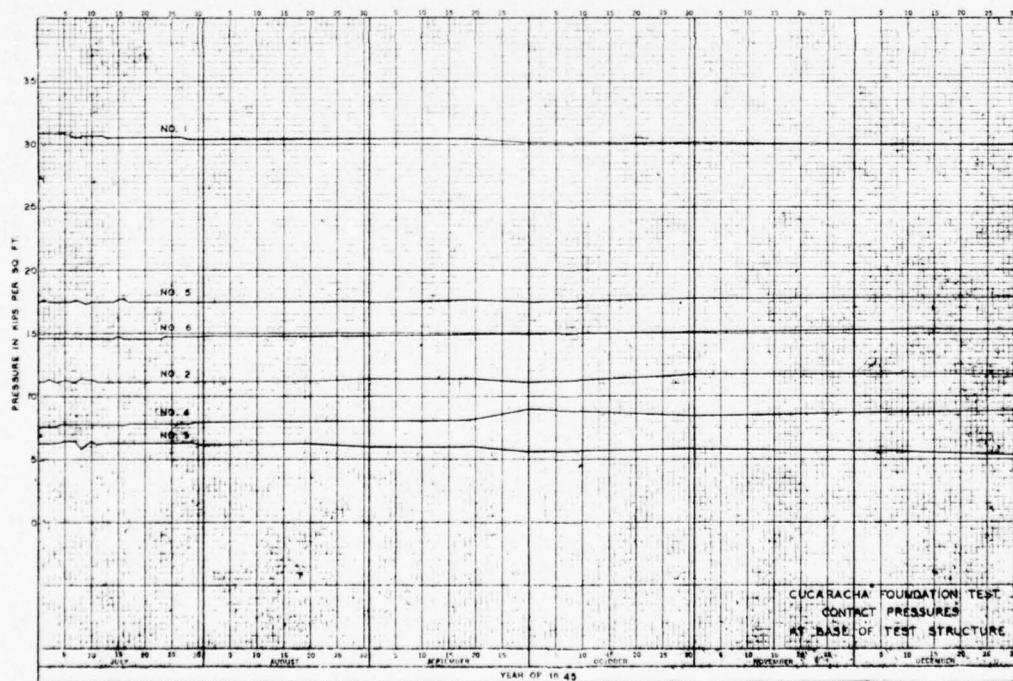
Fig. 39. Contact pressures at base of test structure during 1945

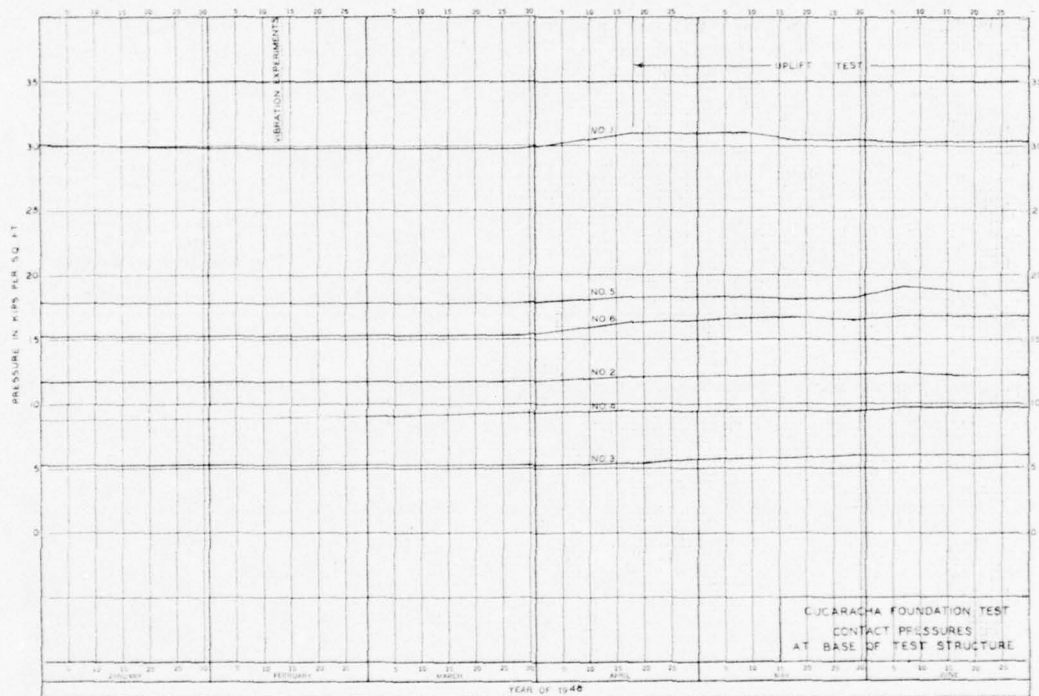
Fig. 40. Contact pressures at base of test structure,
January-June 1946

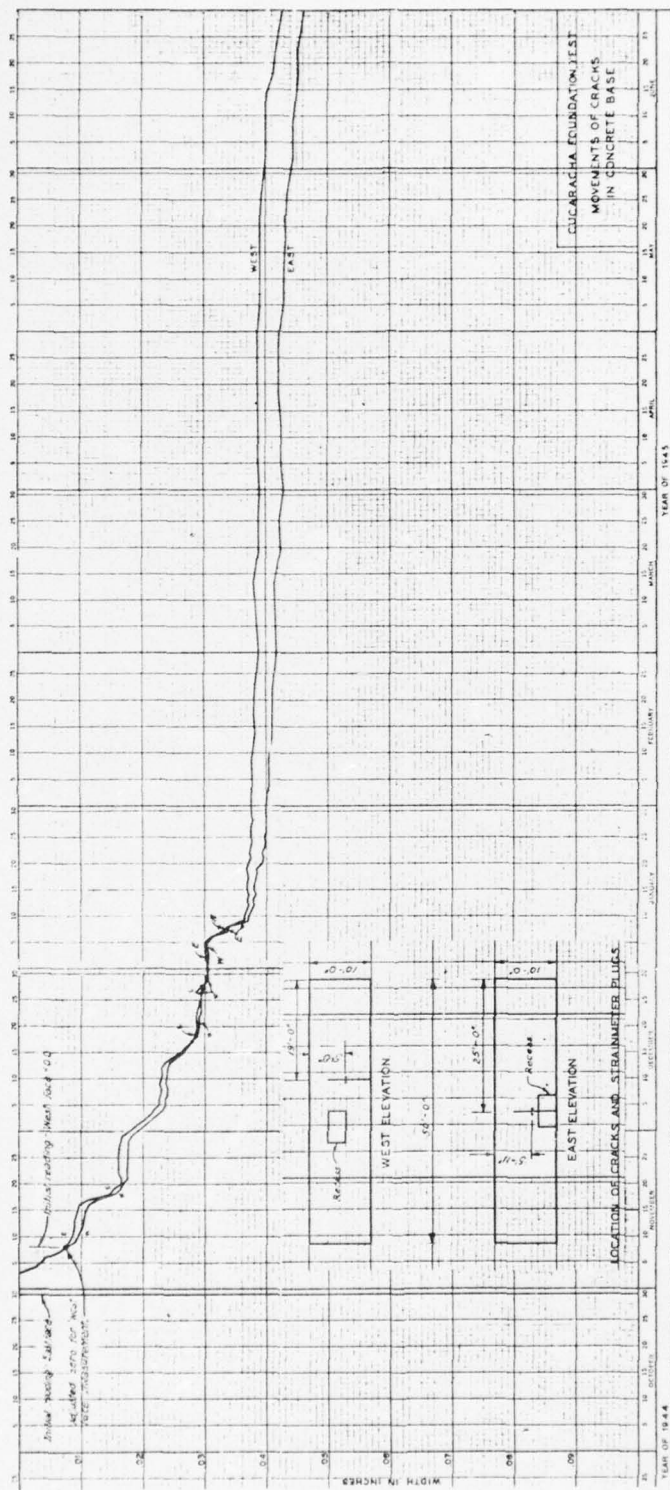
Fig. 42. Movements of cracks in concrete base, 1944-1945

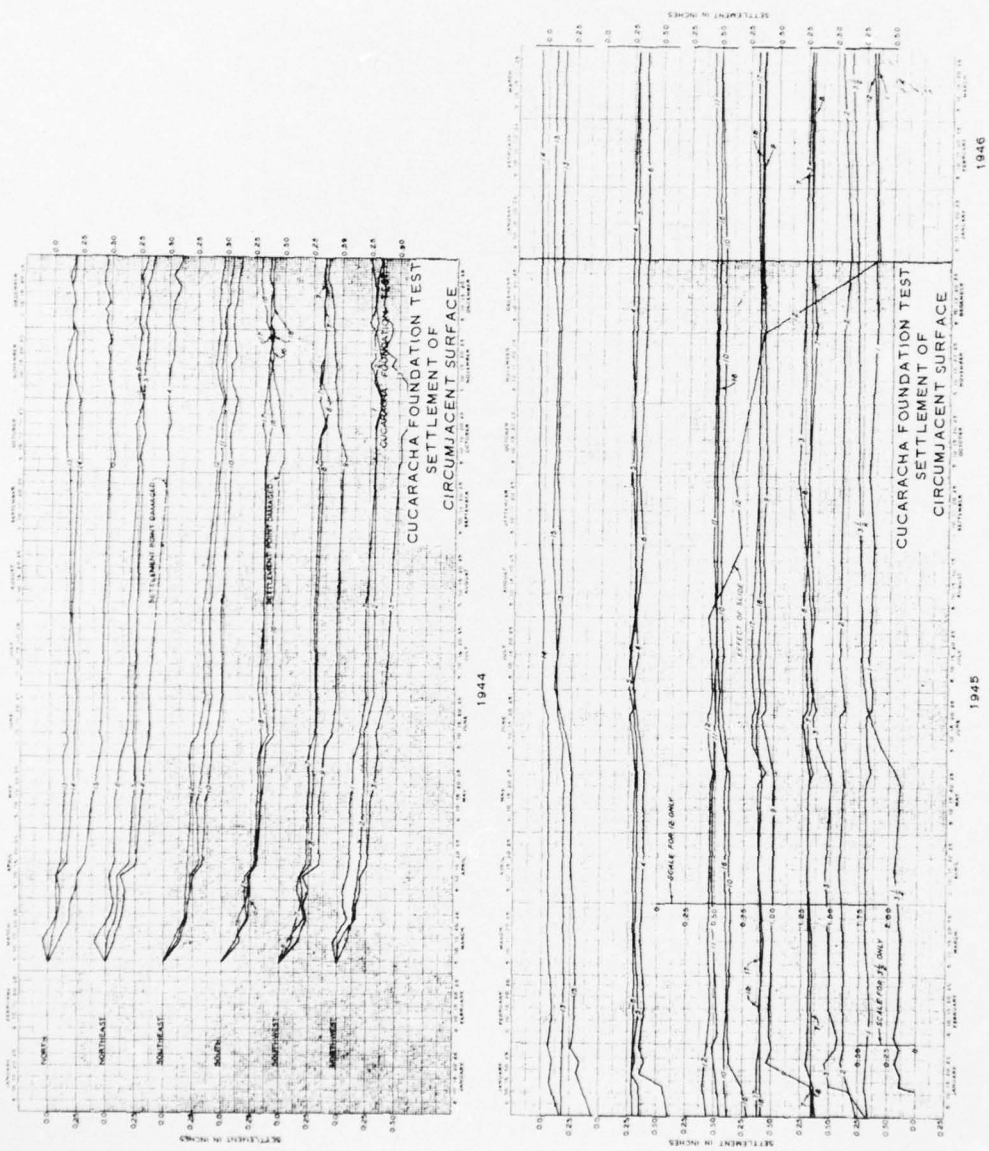
Fig. 43. Settlement of ground surface adjacent to test structure, 1944-1946

93. Settlement of the circumjacent shale surface was very small. Curves of settlement versus time are shown in fig. 43. It is significant that the settlement of the shale surface was less at the north end,

where settlement of the structure was greater, than at the south end. This feature can be attributed to the weaker character of the shale at the north end: it compresses more under load but is less capable of transferring stress to areas outside of the loaded area.

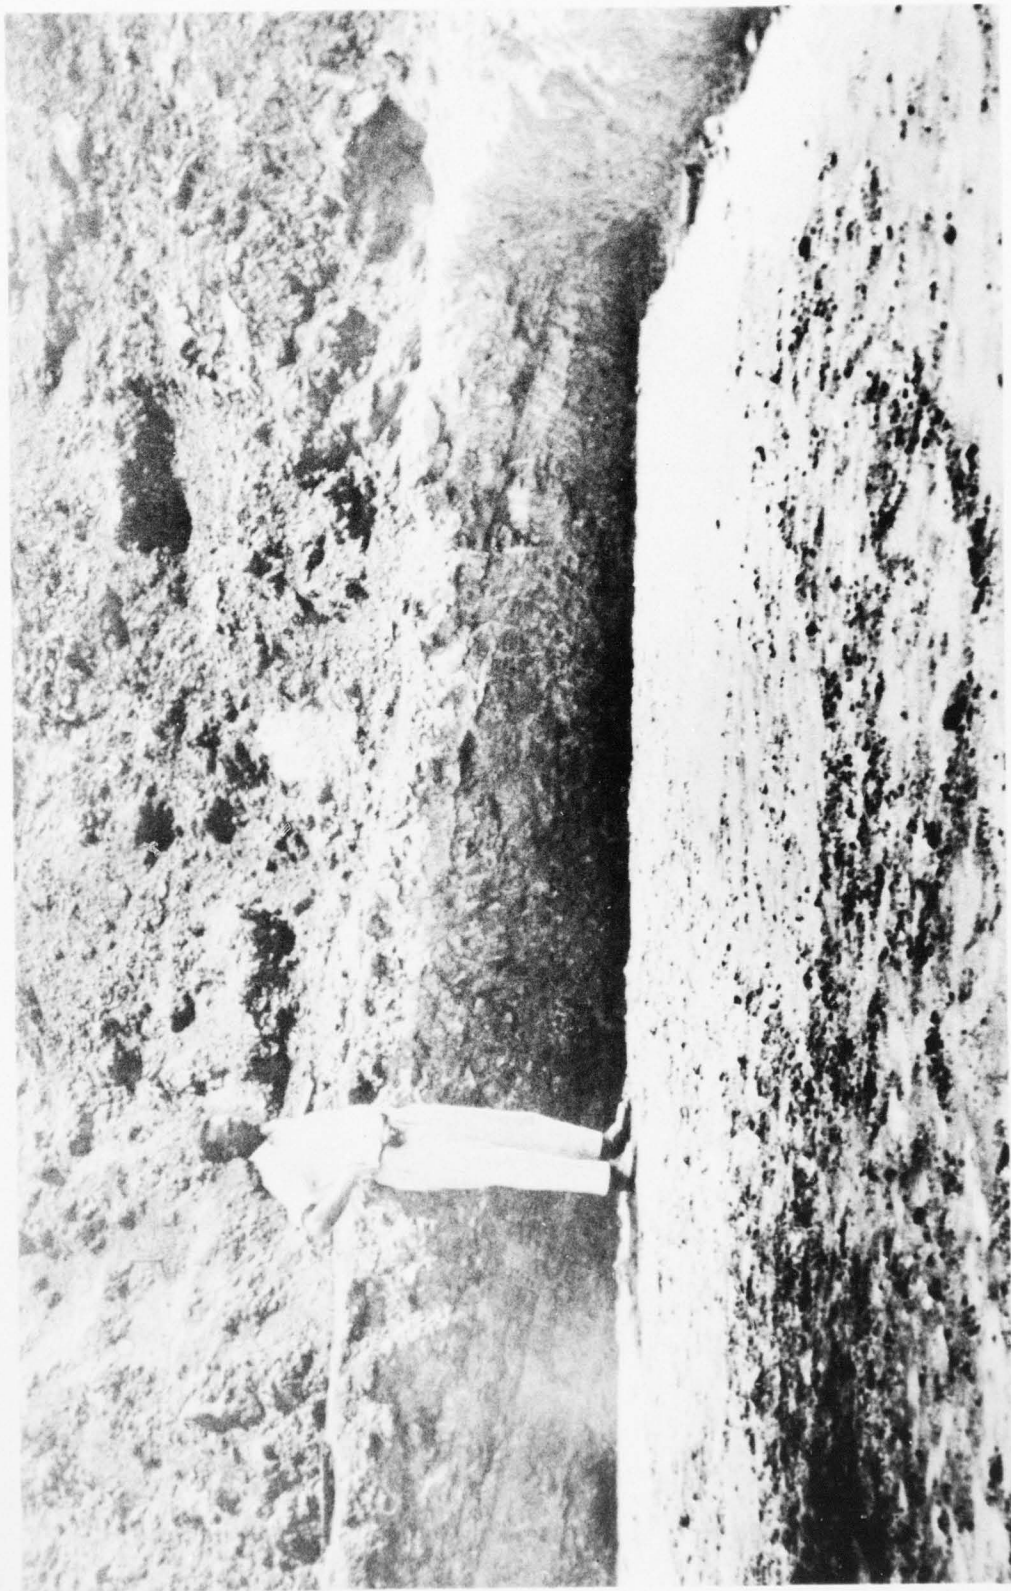
Photo 1. Interbedded black carbonaceous shale and typical green-gray Cucaracha clay shale.
Southwest corner of excavation

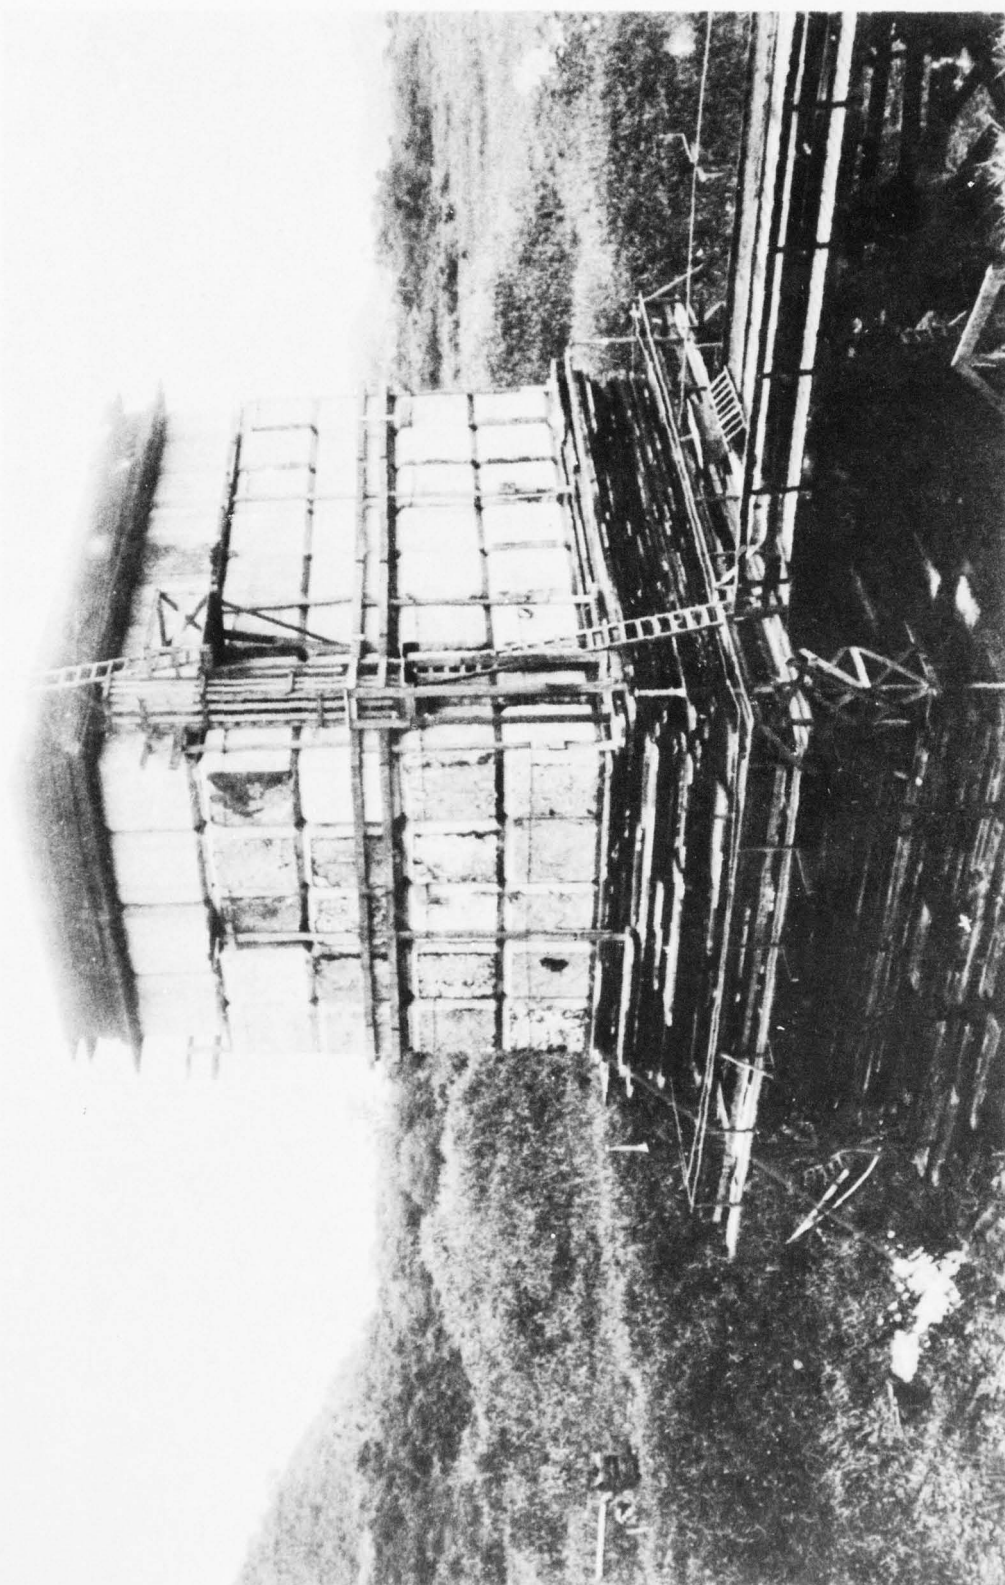
Photo 2. Test structure under maximum loading. Viewed from northwest corner

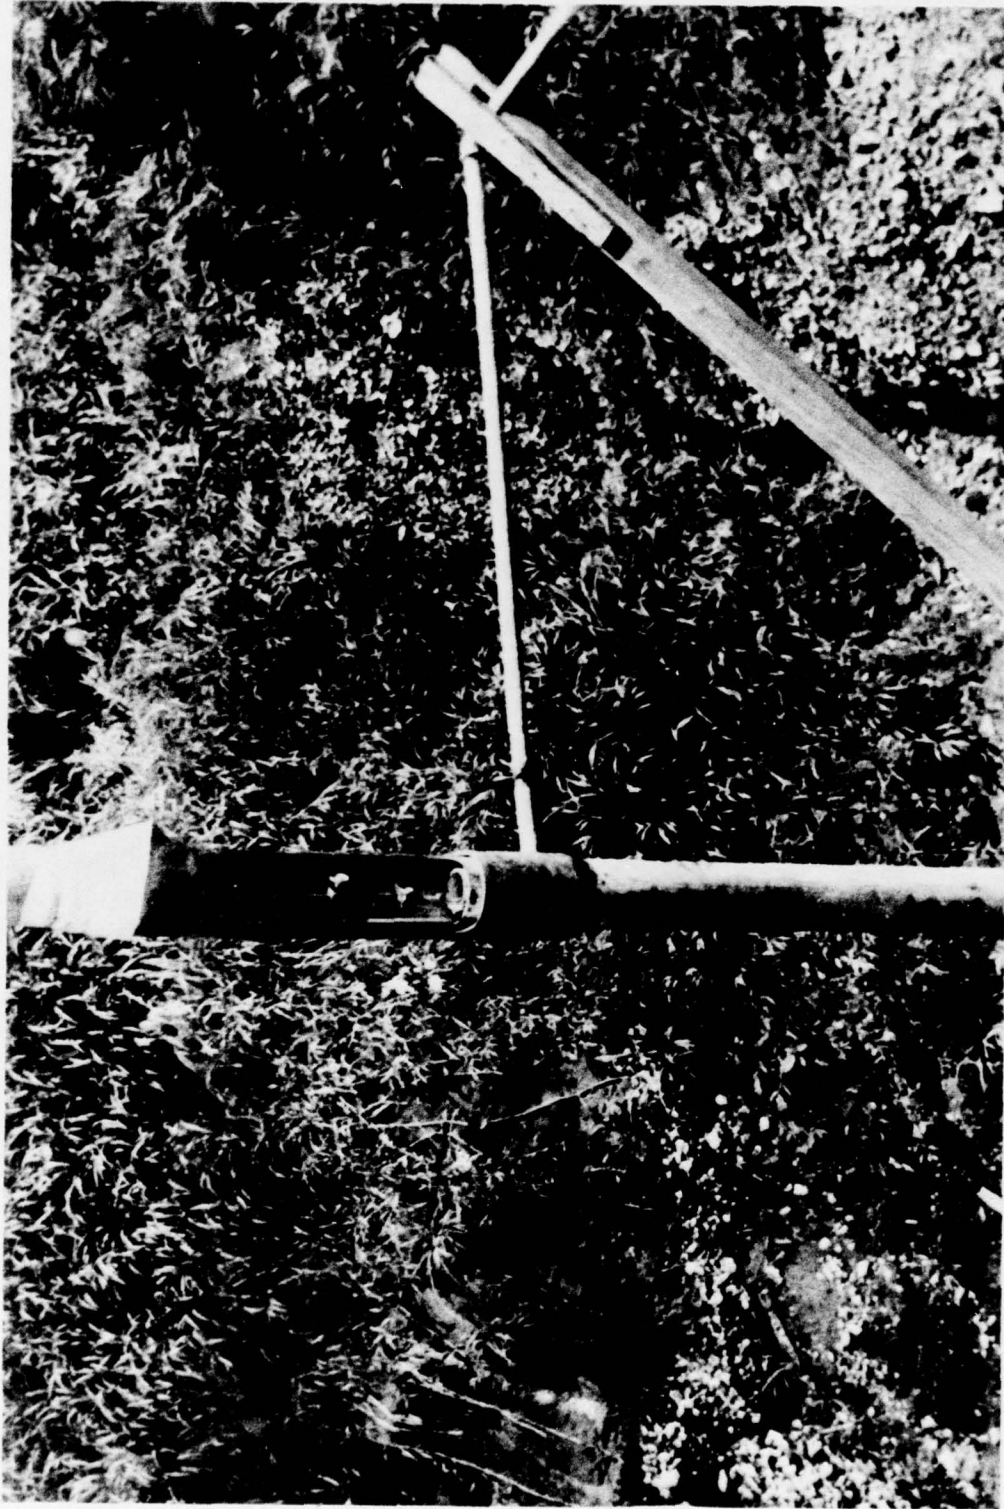
Photo 3. Hook gage assembly for measuring settlement at corners of test structure

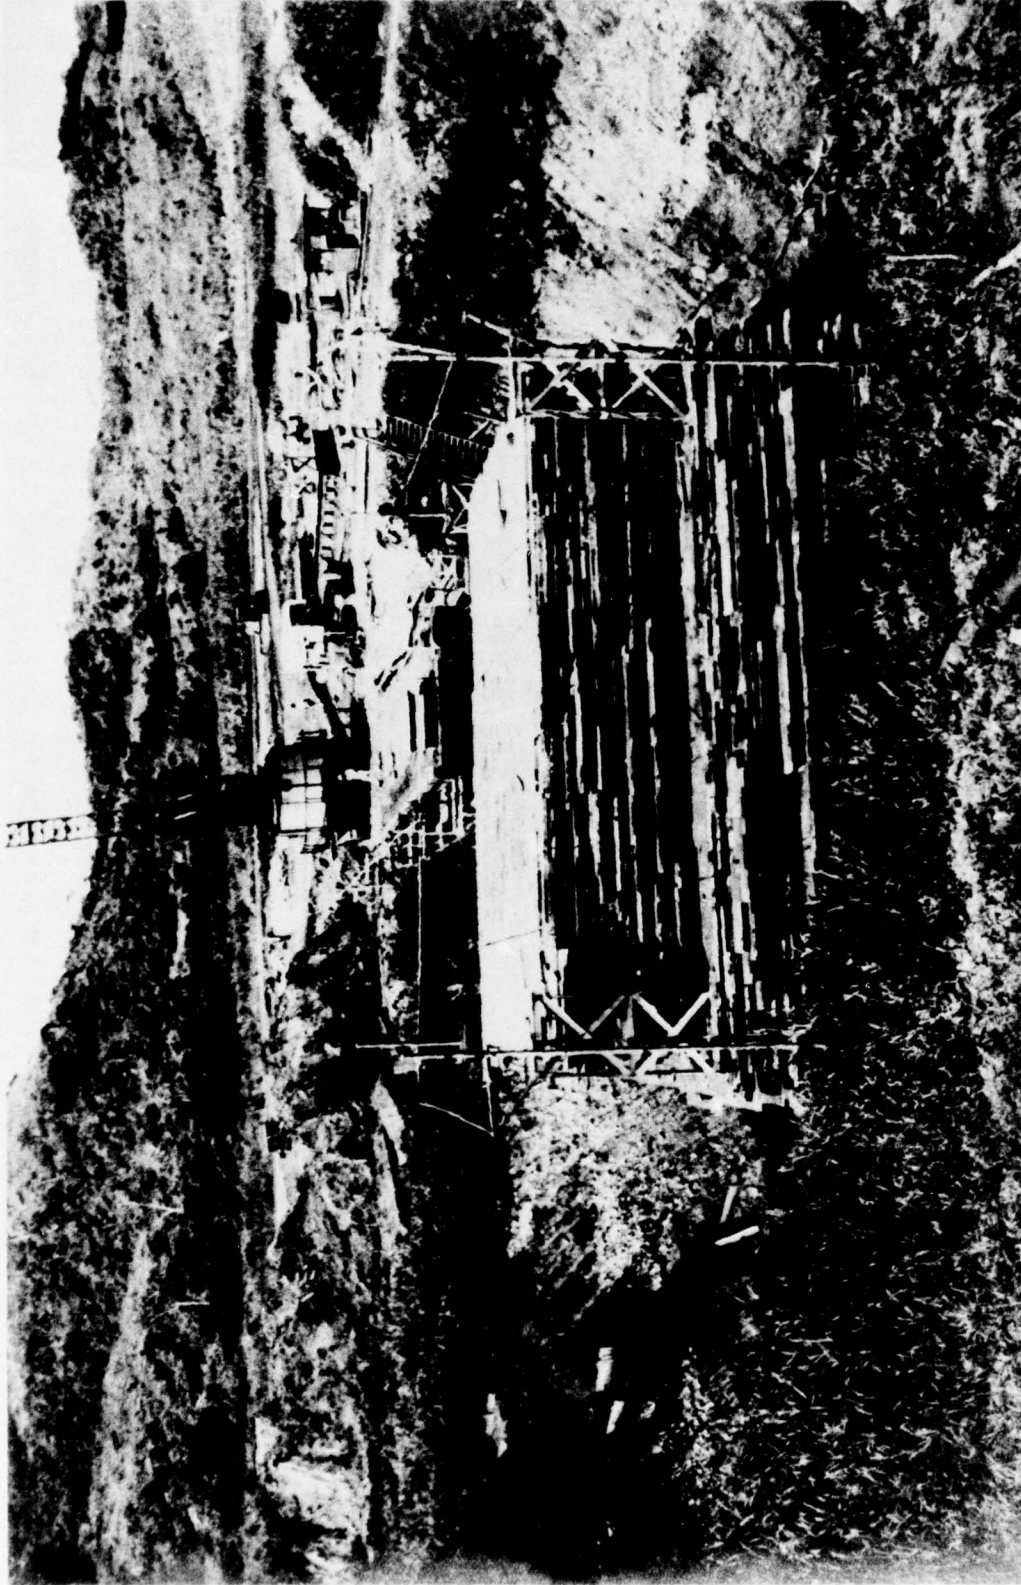
Photo 4. Water line from bench mark in center background to pipe standards for settlement measurements at corners (looking westerly during rest period under load 5)

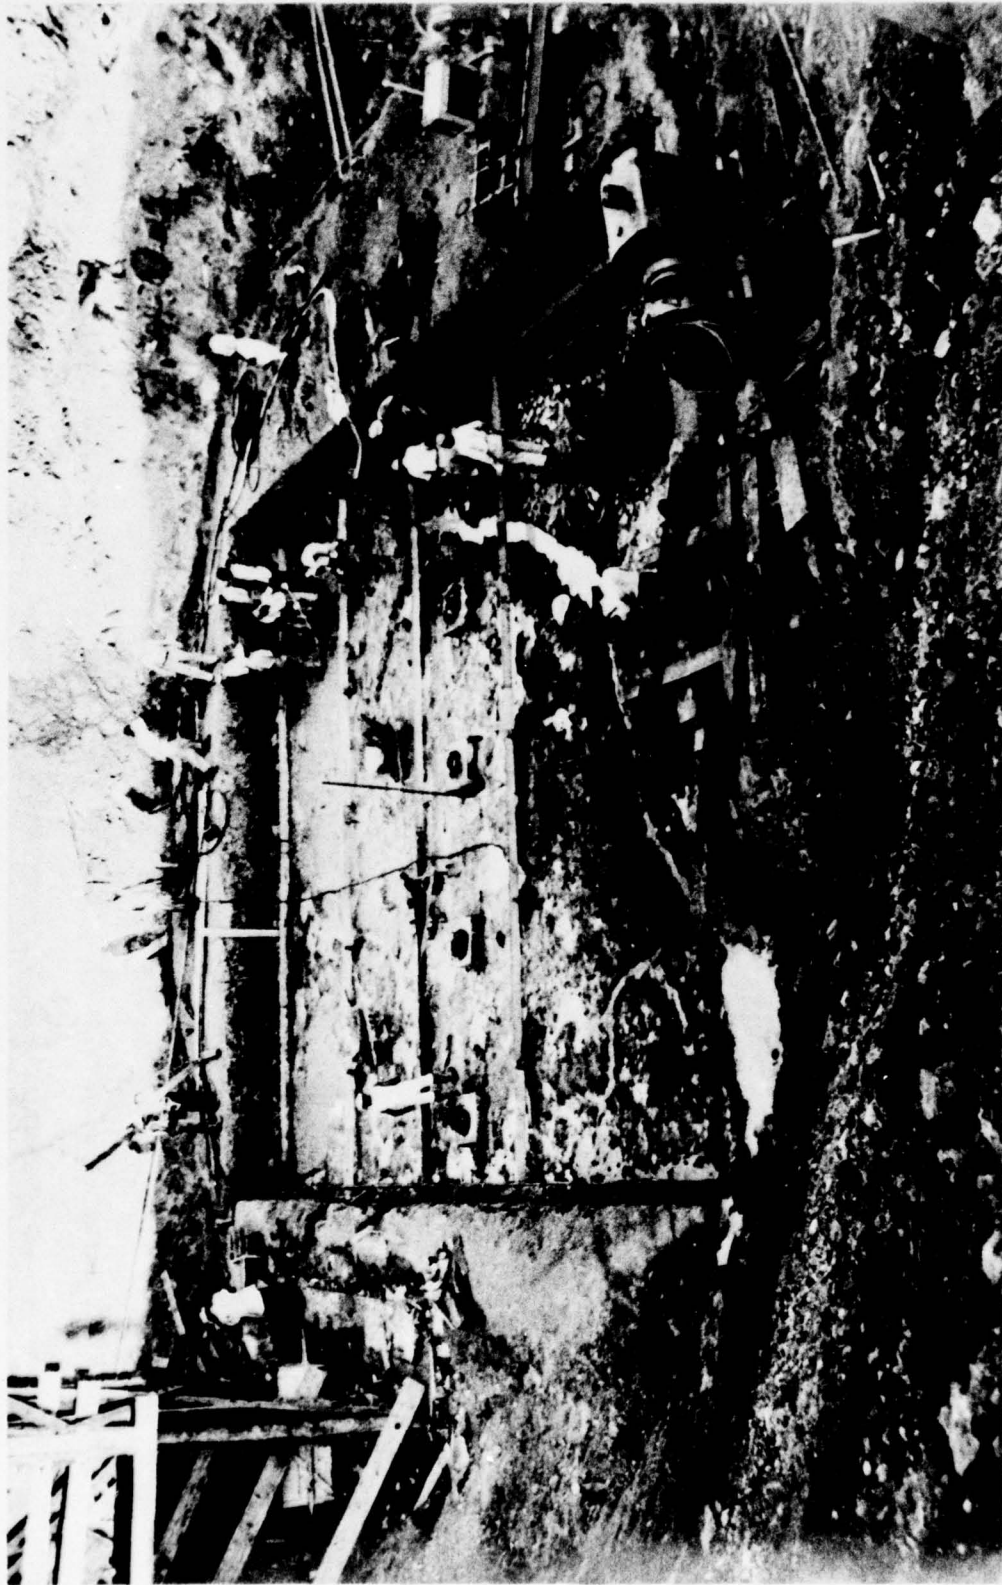
Photo 5. Carlson stress meters on foundation along east-west axis, prior to concrete placement

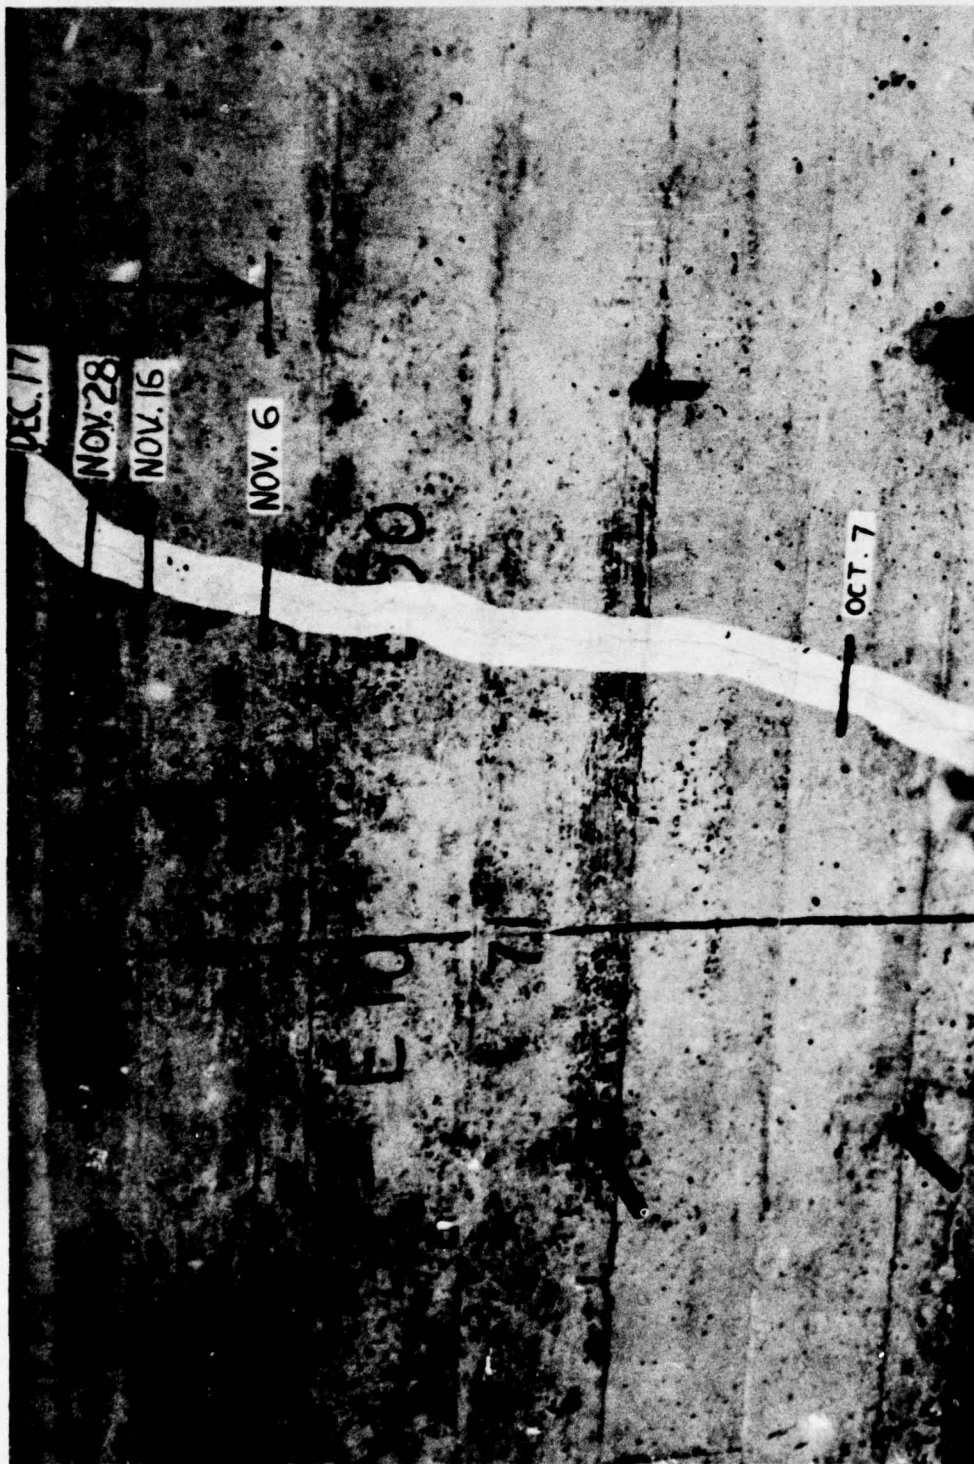
Photo 6. Crack on east side showing rate of development

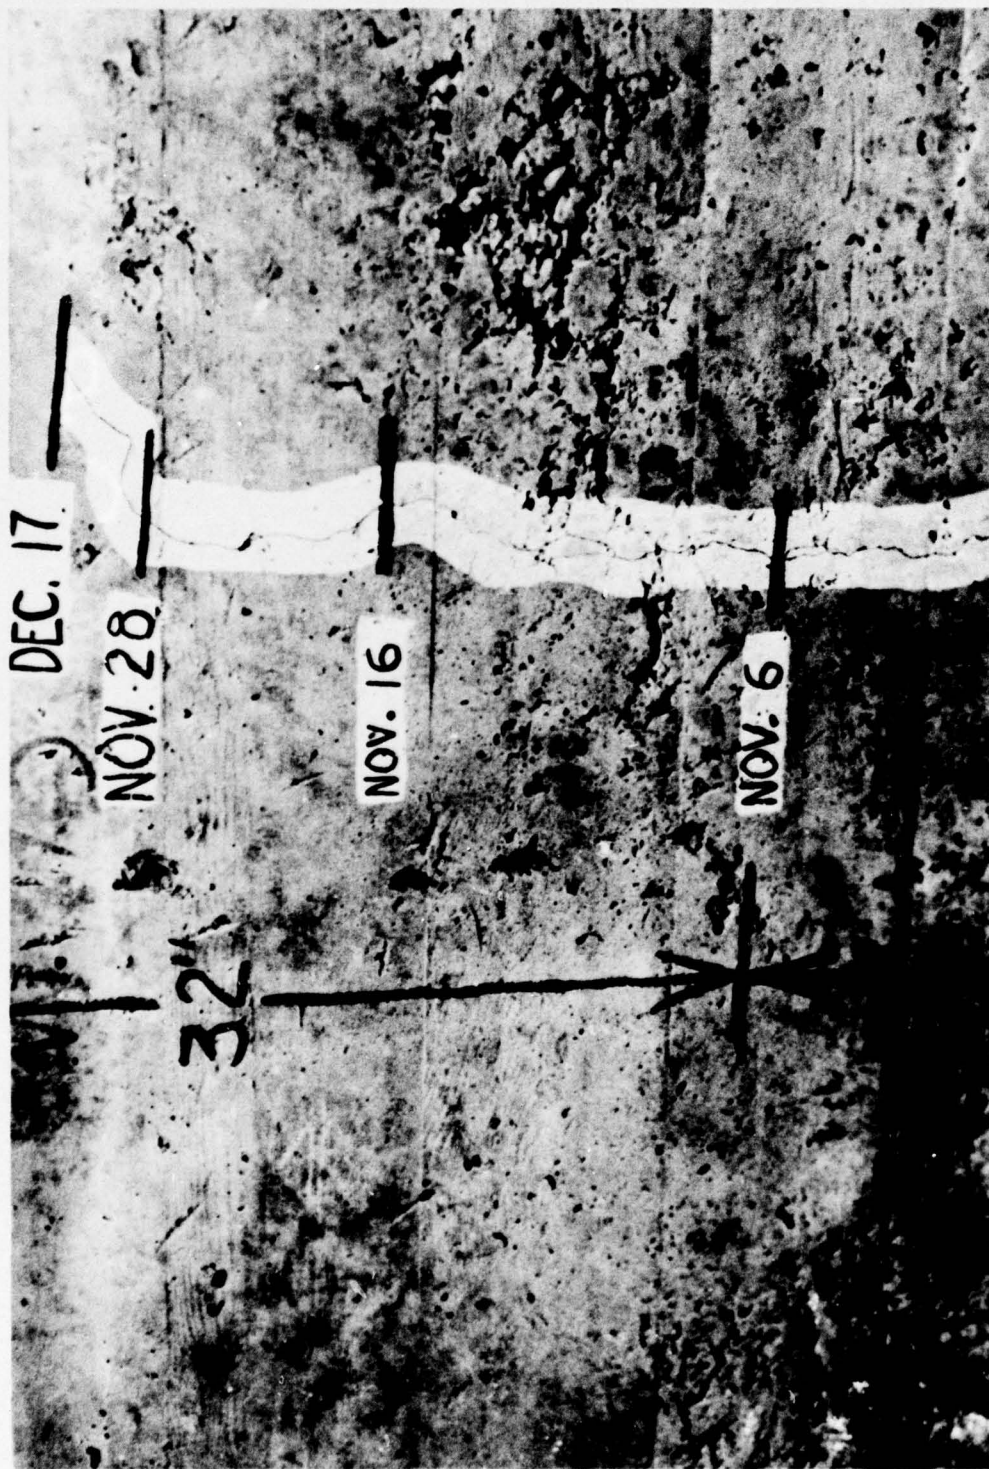
Photo 7. Crack on west side showing rate of development
